*The engineer who oversaw the construction of the World Trade Center “bathtub” describes the recovery efforts.*

# World Trade Center “Bathtub”: From Genesis to Armageddon

George J. Tamaro

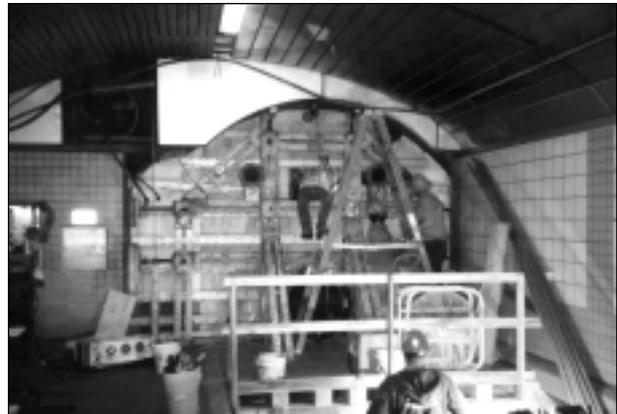
FIGURE 6 Current PATH tube plug at Exchange Place Station in Jersey City.

Concurrent with rescue work in New York, Port Authority engineers were investigating the condition of the PATH tunnels in Jersey City, New Jersey, where the Exchange Place Station, which was at an elevation 5 feet lower than the WTC PATH Station, had served as a sump for fire water, river water, and broken water mains discharging into the bathtub. Inspection indicated that water in the tunnels between New York and New Jersey had completely filled the north tunnel at the midriver low point. Pumps were immediately put into action to keep Exchange Place Station from flooding. As much as

3,000 gallons per minute were pumped from the north tunnel for a 12-hour period each day. Tests of the water were inconclusive as to the source; however, most was believed to come from the vast amounts of water that were poured onto the debris to extinguish continuing fires. Within days, a 16-foot long low-strength concrete plug was placed in each tube as a seal in the event that the bathtub walls were breached and the tunnels fully flooded. The plugs were designed to withstand an 80-foot head of water pressure and will be removed once the slurry walls are fully secured (Figure 6). The Port Authority is currently preparing to remove the plugs in preparation for rehabilitation of the tunnels.

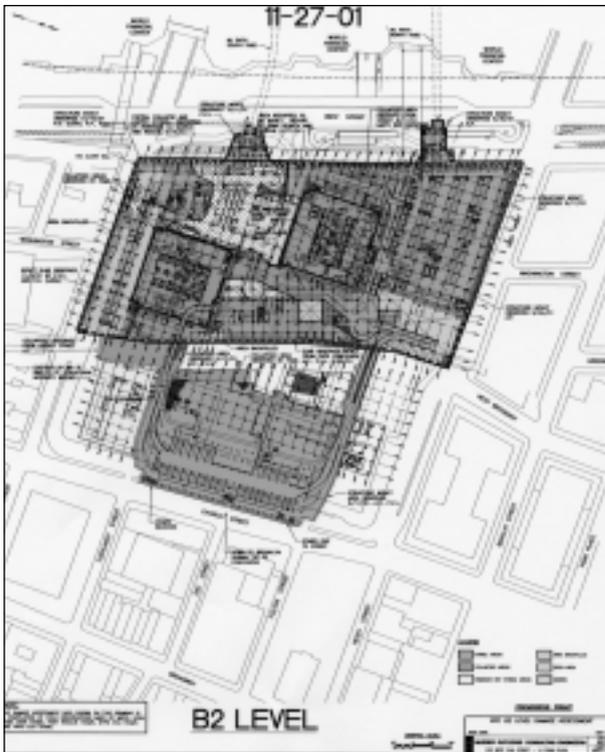
FIGURE 7 Damage assessment drawing for Level B2.

MRCE began to compile information on the condition of the slurry walls and the remaining basement structure as soon as below-grade access was possible. Teams of engineers, including MRCE, TTE, and Leslie E. Robertson Associates (LERA), and rescue personnel from FEMA, the U.S. Army Corps of Engineers, the Fire Department, and the Police Department conducted inspections of all accessible below-grade areas. These teams reported on the condition of the slurry wall, the floor slabs, and the debris fields and judged whether the floor slabs and debris could safely support the slurry walls. MRCE compiled this information on damage assessment drawings showing the locations of stable and collapsed floors, as well as the location of dense debris fields. Those diagrams were used by contractors removing the debris to prevent compromising the slurry walls; the drawings were used by MRCE in the design of the slurry wall resupport system. Figure 7 shows a typical example of a damage assessment drawing for one of the basement levels. The drawings showed that remnants of

the existing floors continued to support the slurry walls in the northern sector of the site. LERA is currently reassessing the condition of the slabs in the northern sector as a temporary support for the slurry wall and for their possible reuse in a reconstructed basement.

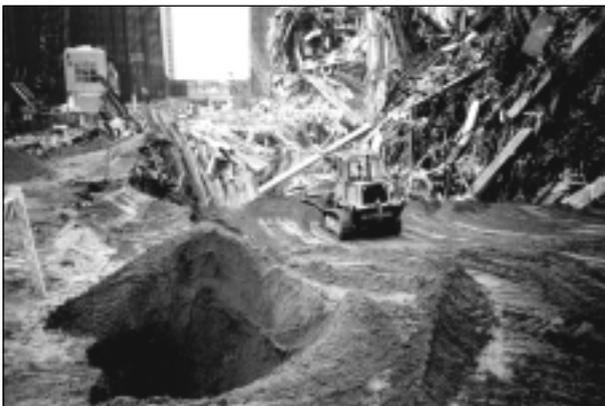
FIGURE 8 Backfill operations at Liberty Street.

In the center sector, the walls were supported by debris that varied from loose to compact. Along the south wall at Liberty Street, the majority of the wall was unsupported for most of its 60-foot height. Ultimately, tension cracks developed in Liberty Street immediately south of the wall, and the top of the wall moved more

than 10 inches toward the site. Backfilling of the south sector began as soon as it became safe to work in the area and the extent of the problem could be determined (Figure 8). Slope inclinometers, survey points, and monitoring wells were used to measure the behavior of the wall and the groundwater levels. Dewatering wells were installed to reduce water pressure on the walls, and instrumentation was installed to measure movements. The instrumentation showed that backfilling had reduced the rate of wall movement to the point that an upper tier of tiebacks could be installed to stabilize the wall. The contractor is currently installing the fourth level of tiebacks at that location in preparation for excavation to track level by March 2002.

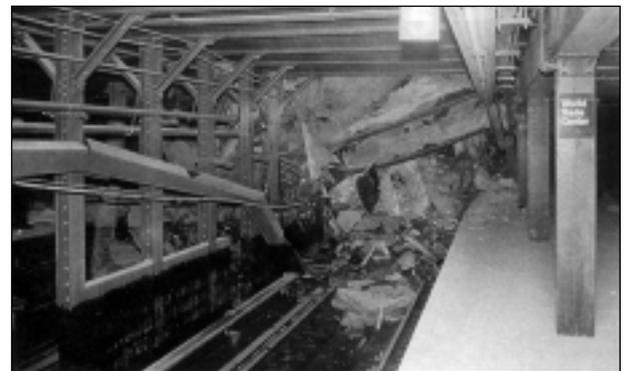
FIGURE 9 Damaged subway tunnel.

An inspection of the subway tunnels immediately east of the slurry wall indicated that the south half of the tunnel was either collapsed or had been pierced by a falling structure (Figure 9); the north half was relatively undamaged. Bulkheads were designed at both ends to prevent inundation of an adjacent section of tunnel that was secure and operating. A more easterly subway tunnel was found to be almost undamaged and was returned to service late in October 2001. New York City Transit has prepared contract documents for reconstruction and reopening of the line by October 2002.

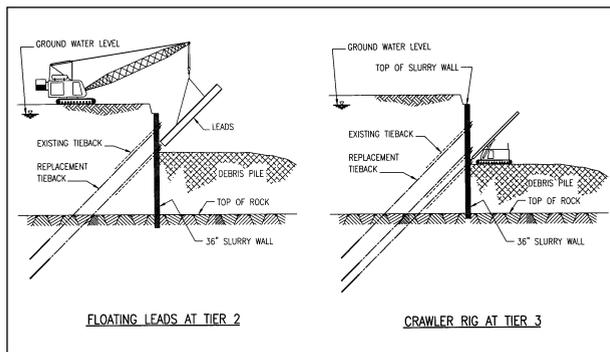
FIGURE 10 Tieback installation with floating leads and crawler rigs.

Tieback work is performed from inside the wall using crawler-mounted drills set on timber mats or from outside the wall using “floating leads” extending over the wall. The floating leads are used where the working surface is unsafe (Figure 10). (Excavating equipment has fallen several floors through the debris on two occasions.)

inspected and found to be unsuitable for reuse. Replacement anchors, intended to be permanently corrosion protected are now being installed on the south half of the bathtub; these anchors will be tested to 400 tons and locked off at 300 tons. Because of the uncertainties about the support of the wall by debris and concerns about sudden loading of the wall as a result of the collapse of the lower level floors, tieback capacity of the top two tiers of anchors was set sufficiently high so that the anchor would not fail prior to development of the ultimate moment capacity of the wall.

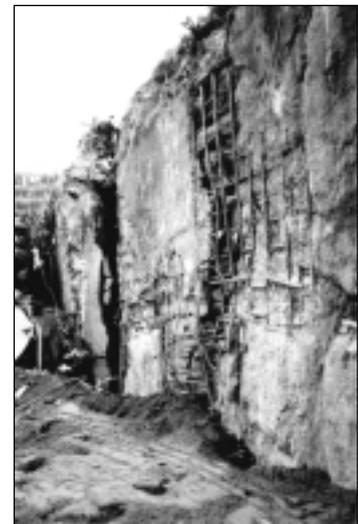
FIGURE 12 Damaged walls at Greenwich Street.

As of January 2002, the slurry wall was found to be mostly intact, except for minor leaks at a few abandoned tieback seals and the

upper portion of two panels at the southeast corner that were crushed by falling debris (Figure 12). The estimated time of removal of all debris is less than one year. The Port Authority has indicated its desire to restore interim PATH service in the area of the former station once the slurry walls are stabilized and the debris removal is completed. Planning for a memorial and commercial and public buildings is under way.
