World Trade Center “Bathtub”: From Genesis to Armageddon

George J. Tamaro is a member of the NAE and senior partner, Mueser Rutledge Consulting Engineers.

George J. Tamaro

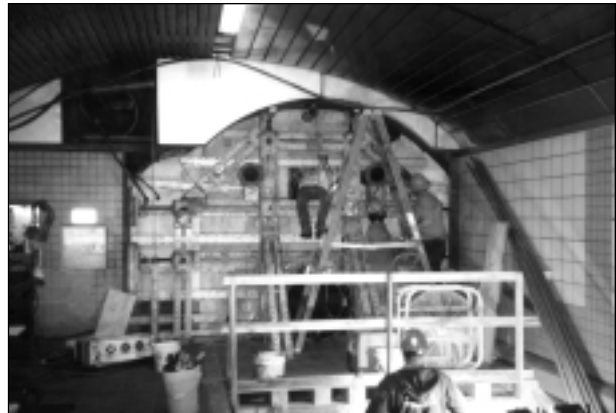
FIGURE 6 Current PATH tube plug at Exchange Place Station in Jersey City.

3,000 gallons per minute were pumped from the north tunnel for a 12-hour period each day. Tests of the water were inconclusive as to the source; however, most was believed to come from the vast amounts of water that were poured onto the debris to extinguish continuing fires. Within days, a 16-foot long low-strength concrete plug was placed in each tube as a seal in the event that the bathtub walls were breached and the tunnels fully flooded. The plugs were designed to withstand an 80-foot head of water pressure and will be removed once the slurry walls are fully secured (Figure 6). The Port Authority is currently preparing to remove the plugs in preparation for rehabilitation of the tunnels.

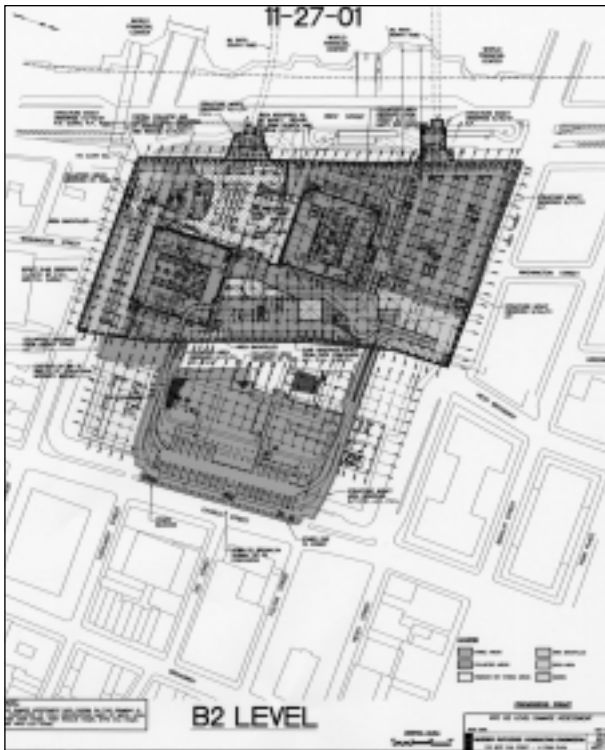
FIGURE 7 Damage assessment drawing for Level B2.

the existing floors continued to support the slurry walls in the northern sector of the site. LERA is currently reassessing the condition of the slabs in the northern sector as a temporary support for the slurry wall and for their possible reuse in a reconstructed basement.

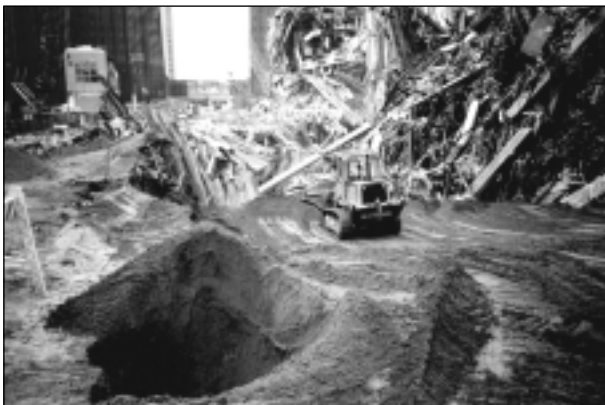
In the center sector, the walls were supported by debris that varied from loose to compact. Along the south wall at Liberty Street, the majority of the wall was unsupported for most of its 60-foot height. Ultimately, tension cracks developed in Liberty Street immediately south of the wall, and the top of the wall moved more

FIGURE 8 Backfill operations at Liberty Street.

than 10 inches toward the site. Backfilling of the south sector began as soon as it became safe to work in the area and the extent of the problem could be determined (Figure 8). Slope inclinometers, survey points, and monitoring wells were used to measure the behavior of the wall and the groundwater levels. Dewatering wells were installed to reduce water pressure on the walls, and instrumentation was installed to measure movements. The instrumentation showed that backfilling had reduced the rate of wall movement to the point that an upper tier of tiebacks could be installed to stabilize the wall. The contractor is currently installing the fourth level of tiebacks at that location in preparation for excavation to track level by March 2002.

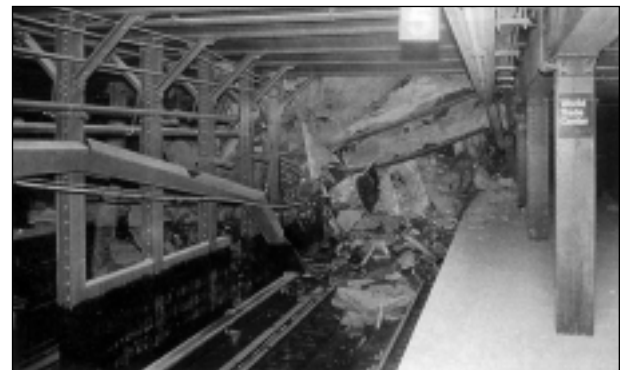
An inspection of the subway tunnels immediately east of the slurry wall indicated that the south half of the tunnel was either collapsed or had been pierced by a falling structure (Figure 9); the north half was relatively undamaged. Bulkheads were designed at both ends to prevent inundation of an adjacent section of tunnel that was secure and operating. A more easterly subway tunnel was found to be almost undamaged and was returned to service late in October 2001. New York City Transit has prepared contract documents for reconstruction and reopening of the line by October 2002.

FIGURE 9 Damaged subway tunnel.

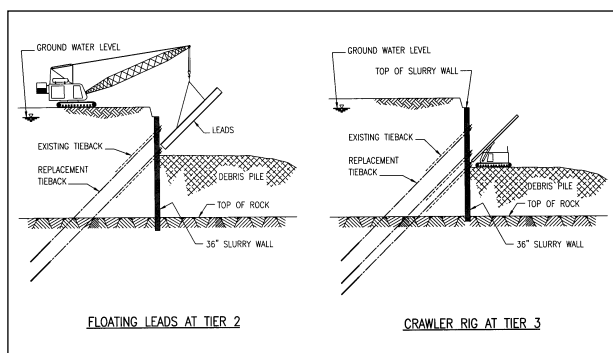
FIGURE 10 Tieback installation with floating leads and crawler rigs.

Tieback work is performed from inside the wall using crawler-mounted drills set on timber mats or from outside the wall using “floating leads” extending over the wall. The floating leads are used where the working surface is unsafe (Figure 10). (Excavating equipment has fallen several floors through the debris on two occasions.)

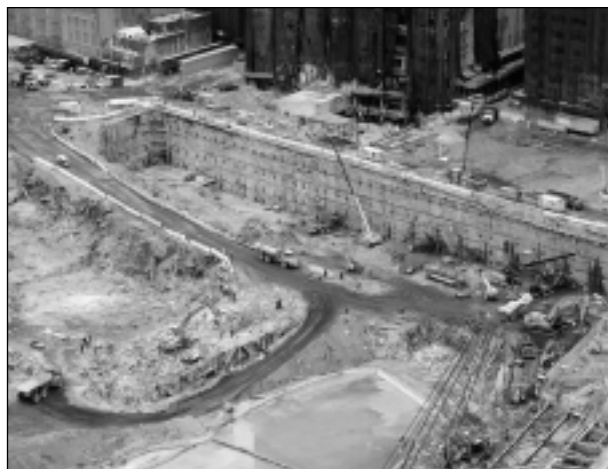
FIGURE 11 Progress along the Liberty Street slurry wall showing the installation of the fourth-tier anchors.

The current design requires one less tier of anchors at each wall section than was used in the original construction. At several tiers, the replacement tieback anchors will be placed either directly above or below abandoned anchors; at other tiers, the replacement anchors will be remote from abandoned original anchors. The first three tiers of anchors at the south wall were in place, and work had begun on the fourth tier as of January 2002 (Figure 11). First and second tier anchor installation on West and Greenwich Streets is proceeding from south to north as debris is removed and work space becomes available. Tiebacks will also be required

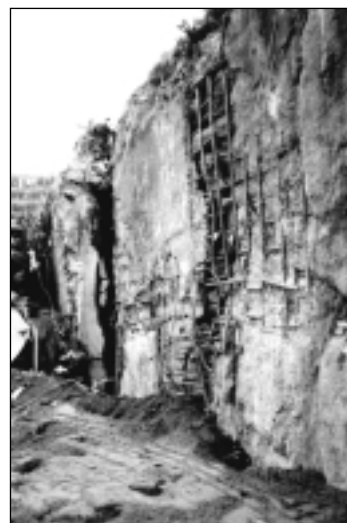
As of January 2002, the slurry wall was found to be mostly intact, except for minor leaks at a few abandoned tieback seals and the upper portion of two panels at the southeast corner that were crushed by falling debris (Figure 12).

FIGURE 12 Damaged walls at Greenwich Street.
